SLICK SB3-08A

Service Bulletin

SUBJECT: Mandatory inspections on all Slick 4200/6200/4300/6300 and LASAR™ 4700/6700 magnetos

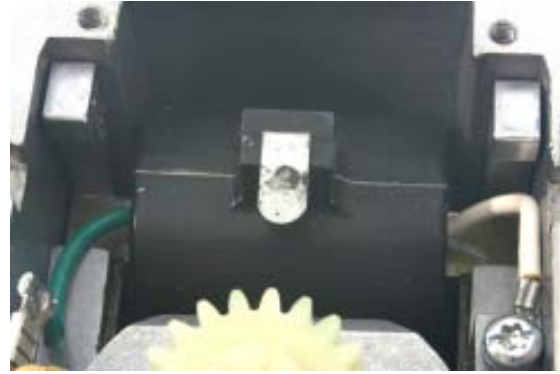
Evidence of Improper Wear of Carbon Brush
Figure 2

- Inspect coil tab for carbon residue coating left by carbon brush. See Figure 2. **REPLACE CARBON BRUSH PER THE APPLICABLE MAINTENANCE AND OVERHAUL MANUAL IF SUBSTANTIAL RESIDUE IS FOUND ON COIL TAB.** Use a cotton swab and alcohol to remove residue from coil tab, or replace coil if tab cannot be cleaned. Also inspect high tension coil tab for wear caused by carbon brush. Wear is indicated by a visible depression in the tab. If tab is worn, replace coil.

Acceptable

Unacceptable

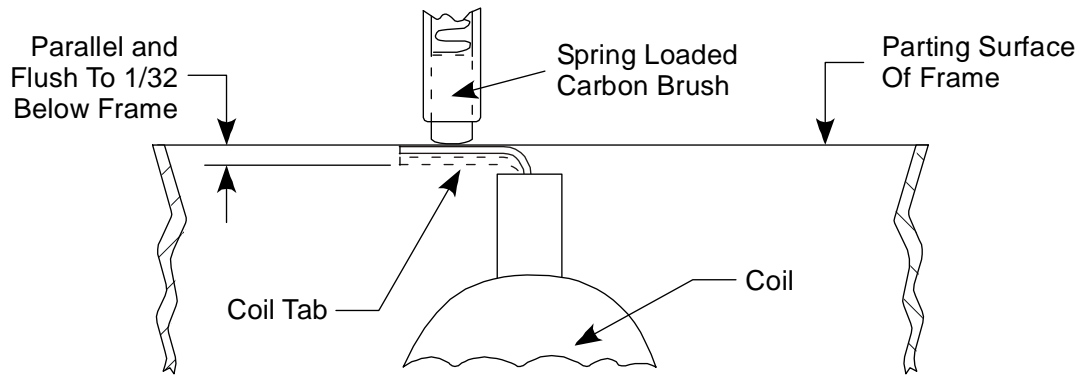
Coil Tab Positioning
Figure 4

CAUTION: IF THE COIL TAB PROTRUDES ABOVE THE MAGNETO FRAME, IT CAN MAKE DIRECT CONTACT WITH THE DISTRIBUTOR GEAR AXLE AND CAUSE THE MAGNETO TO MALFUNCTION.

- Prior to installing distributor block, make sure coil tab is parallel to and flush with frame mating surface to within 1/32 inch. See Figure 4.
