American Champion Aircraft Corp. Rochester, WI 53167

Service Letter : 406 Revision A

Title: Wood Spar Inspection

Applicable Models: All Model 7's, 8's and 11's with wood spar wings

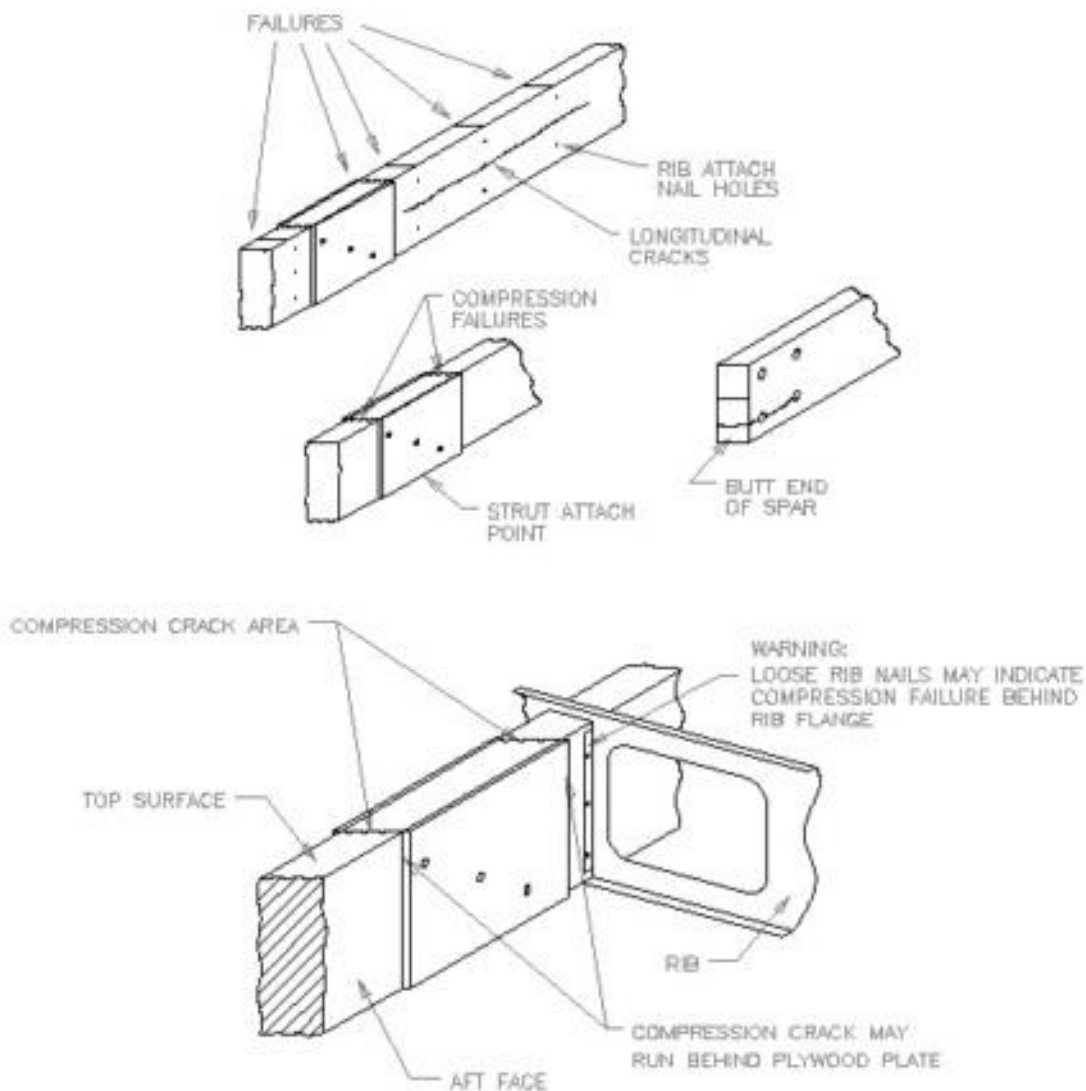
Description: There have been reports of cracks developing in wood spars, both front and rear. There are many possible causes to the cracking including: high flight time, wing damage history, high acrobatic time, over-stress history, or having been exposed to changes in humidity over several years. Compression cracks have been found emanating from the upper and lower surfaces of the front and rear wing spars at both ends of the reinforcement plate for the lift strut attachment. Longitudinal cracks have been reported in all areas of both front and rear spars, including through the wing root. See figure 1 for example locations of spar cracks.

Inspection: The only area where it is possible to positively identify a compression crack is on (Bottom/Top) the top and bottom surfaces of the spar. Both front and rear spars need to be inspected. The key areas to be concerned with are shown in figure 1. Additional inspection holes may be necessary to do a thorough inspection. Service Letter 417, Revision C, may be used as a guide for installing additional inspection holes.

Instructions: If any damage was found in above inspections, it requires that the spar be repaired or replaced. Minor chafing and small indentations are not cause of rejection. Spar repair shall be accomplished in accordance with AC 43.13-1A Acceptable Methods, Techniques and Practices or other Federal Aviation Administration approved data.
